Principal: The New Rijksmuseum
Main contractor: BAM Civiel bv
Execution period: 2009-2010
Machine: AVN
Pipes: steel
DN: 300 - 800 mm
Length: 7 - 24 m
Amount of pressings: 45 p
Depth: 2 - 5 m below ground level

The New Rijksmuseum: a total renovation

Pipe jackings part of the energy installation

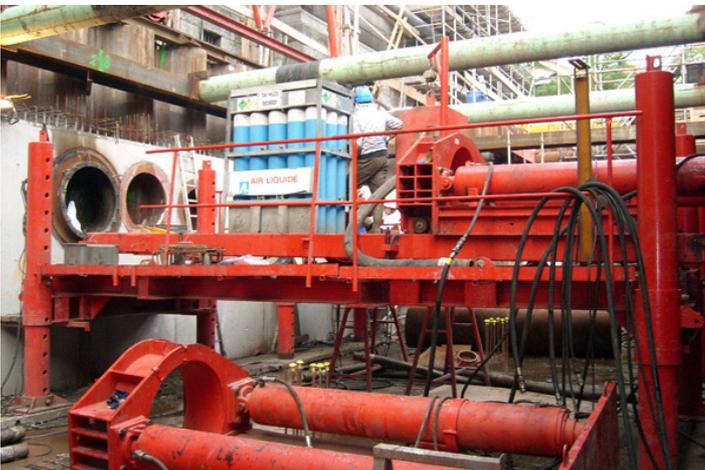
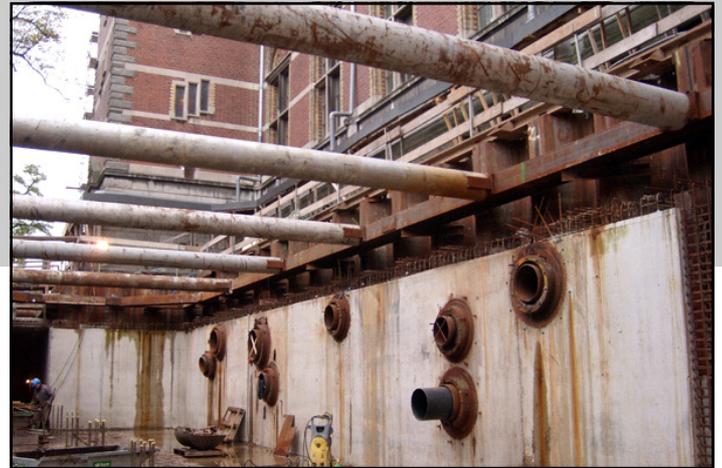
All 45 pipe jackings are located between -2m and -5m NAP and go through the ruins, sand, peat and other piled up material where the Rijksmuseum was built on 200 years ago. Connections with this method are made between the museum halls and the underground ring round the museum where all installations are stored. The longer pipe jackings (24m) arrived in the courtyards. The short pipe jackings (8m) arrive in the basement, the vaulted basements, where receiving pits are made for this occasion. The diameters of the pipe jackings vary between 300 and 800mm.

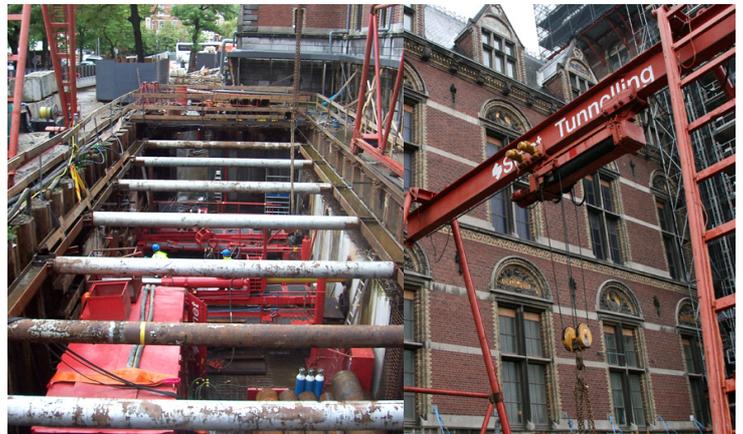
Drilling through existing foundations

The entire Rijksmuseum is founded on approximately 10.000 wooden poles. It was impossible to fully avoid them during the execution of the pipe jackings. Therefore, a careful inquiry was necessary to find out which poles would be drilled through. These had to be overcome first, through placing of new cross beams and pole foundations. This was necessary to guarantee the stability of the museum at any time.
